# **Conservation of the Monuments of Sneferu at Dahshur**

by Rainer Stadelmann Project Director

Description of the work executed from November 2005 till end of November 2006 in the Bent Pyramid and in the valley temple of King Sneferu at Dahshur, as well as an additional restoration work of the pyramidion of the Red Pyramid

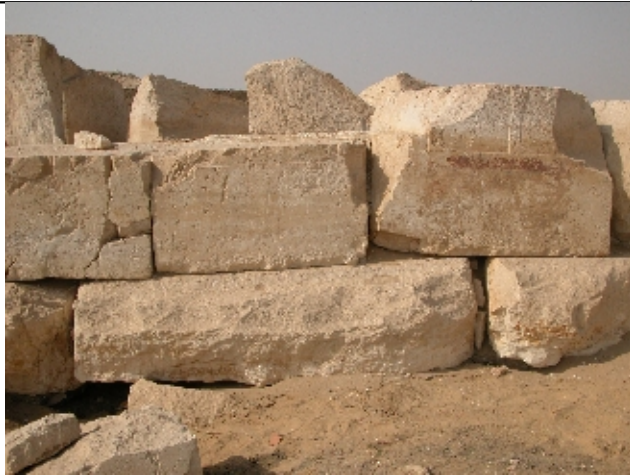
**Fig. 1** foundation problems in the walls caused by the slight slope of the ground on which the temple was built

**a** : areas with structural instability which need a stabilization/ reinforcement: in each case an explanation for the extensive damages on the blocks had to be found. The ensemble of the structural situation and the general geological picture of the area produces an explanation on the structural disorder of the walls in the temple and explain the masonry defects in other structures in Dahshur. An investigation of the soil layers might be of great help. The main aim of this investigation, no matter to which level we can raise it, is to secure the structural stability.

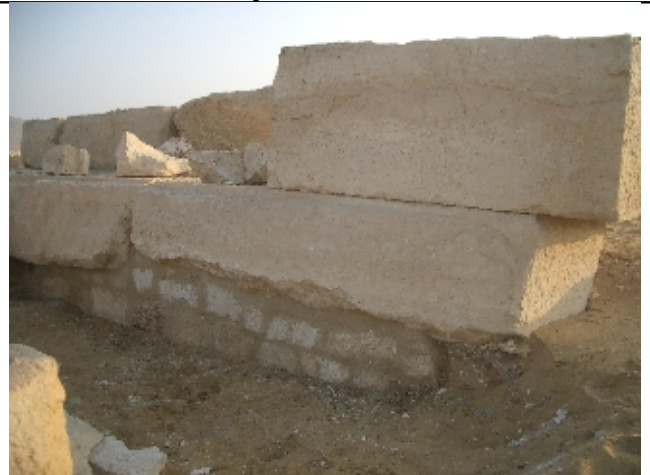
**Fig. 2** the new foundation

By supporting the wall with new foundation blocks of a small size the wall could be stabilized.

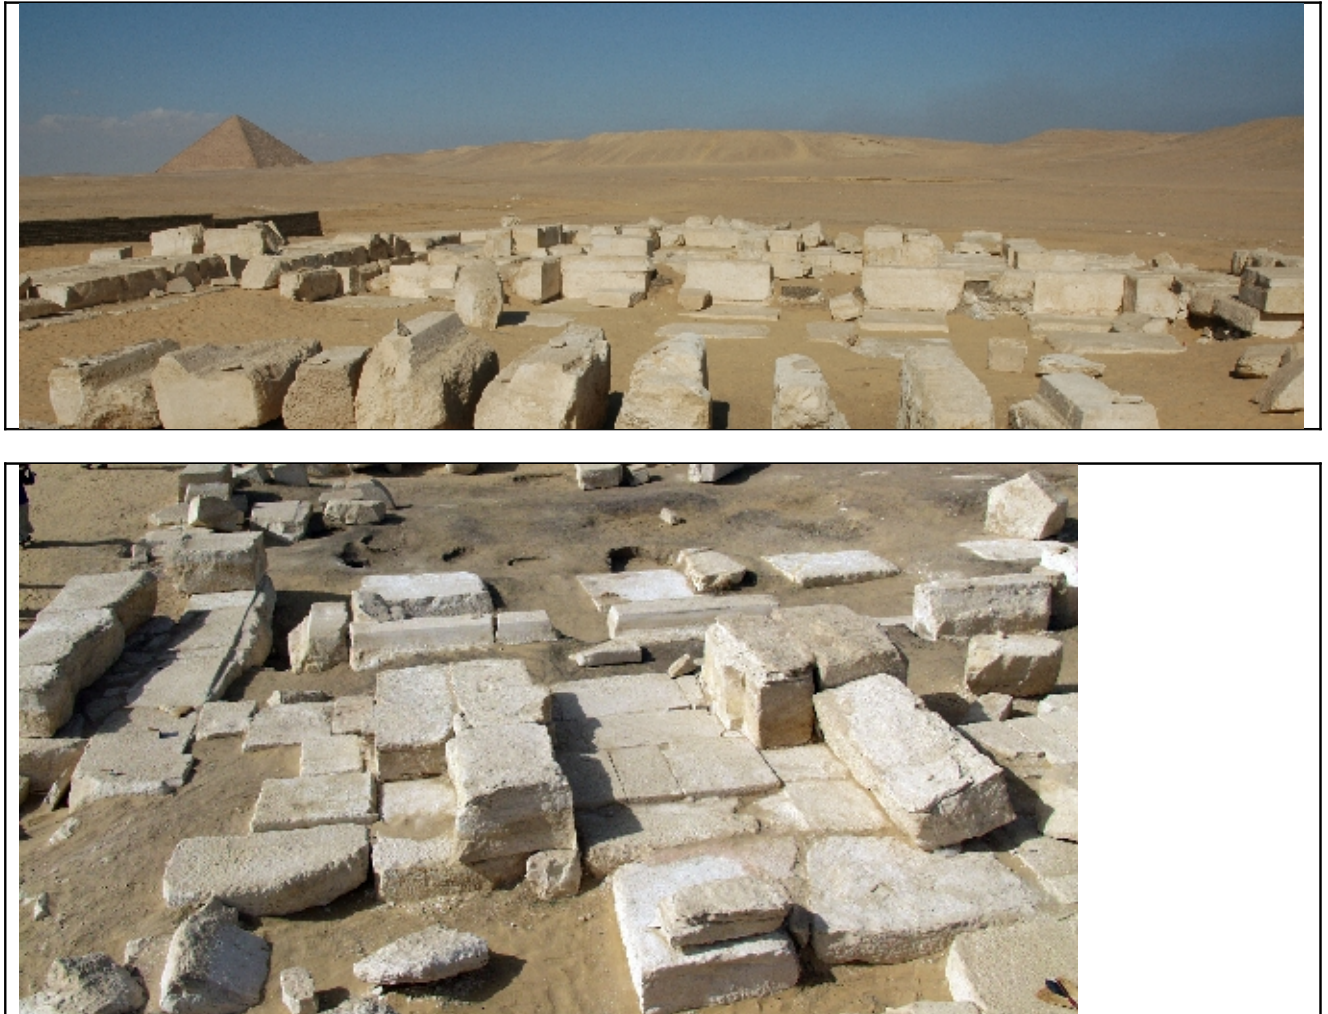
**Fig. 3 and b** Panoramic views of the porch area today with the limestone foundations of the pillars

The **porch** consists of two rows of each of **five right-angled monolithic pillars** (front row 1.20m thick, back row 1.40m, while the breadth varied between 1.85 and 2.10m ... According to Fakhry, the back pillars were broader because they had to carry slabs on both directions ... Peculiar bases with bevelled edges ... The Faces of the pillars were ornamented with relief with the exception of the side of the front row facing the chapels ...

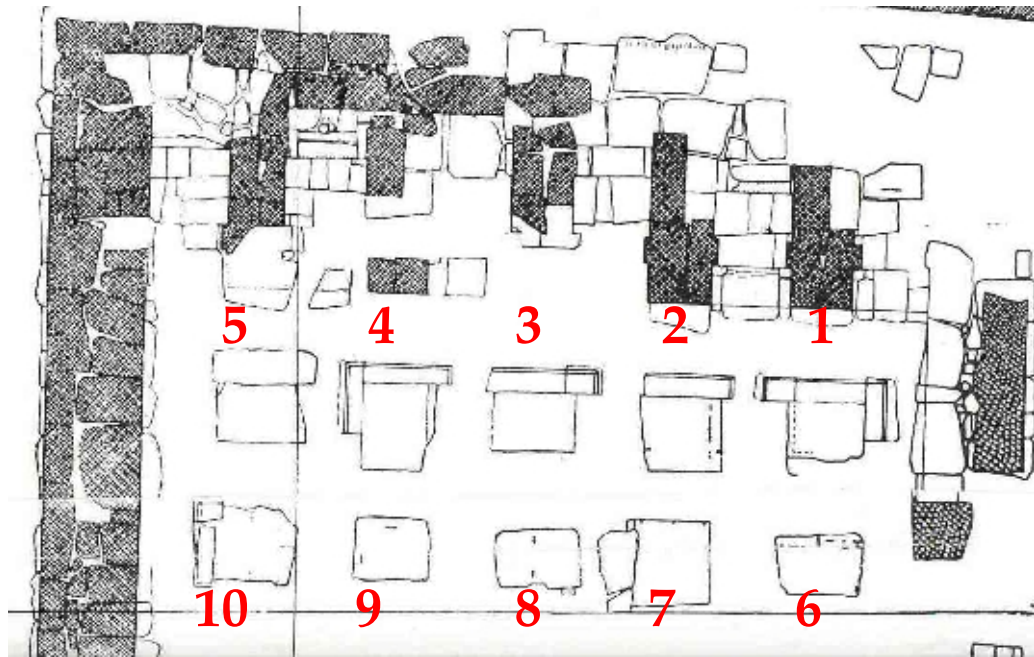
Fig. 4 Plan of the basis of the pillars in the porch

According to our survey the blocks in situ, as well as the signs left by the master-planner masons of the temple on them, we have confirmed that the westernmost and easternmost 4 pillars measured 2.16 m in length, while the middle remaining 6 pillars measured only 1.65m. But the breadth of the pillars were not categorically different from one row to the other, as these varied between 1.45m to 1.36m, contrary to Fakhry's estimations. As a result of this first investigation the plan presented below was produced.

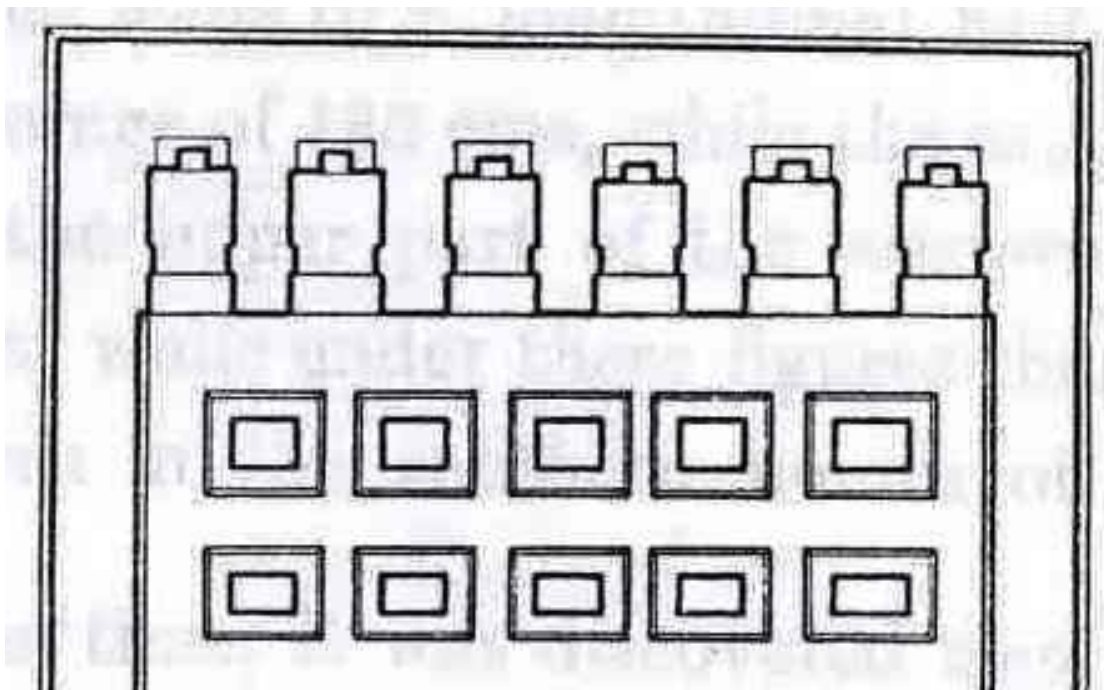
Fig. 5 The porch and the six chapels behind the porch. Reconstruction by H. Ricke

H. Ricke in Fakhry's publication has translated the archaeological survey to an architectural plan, which we have also done and the results were very similar with some differences that are mentioned below.

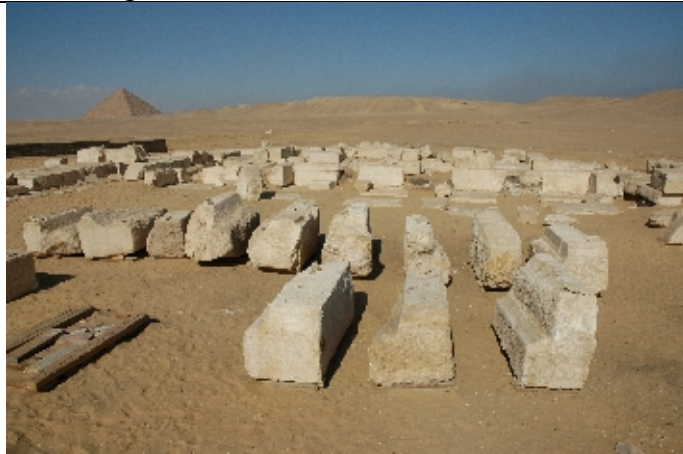
**Fig. 6** blocks of the framing of the pillars assorted according the measurement of the limestone bases

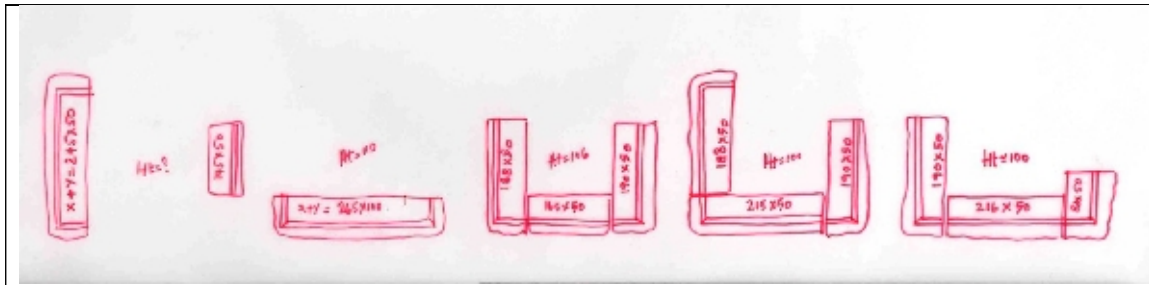
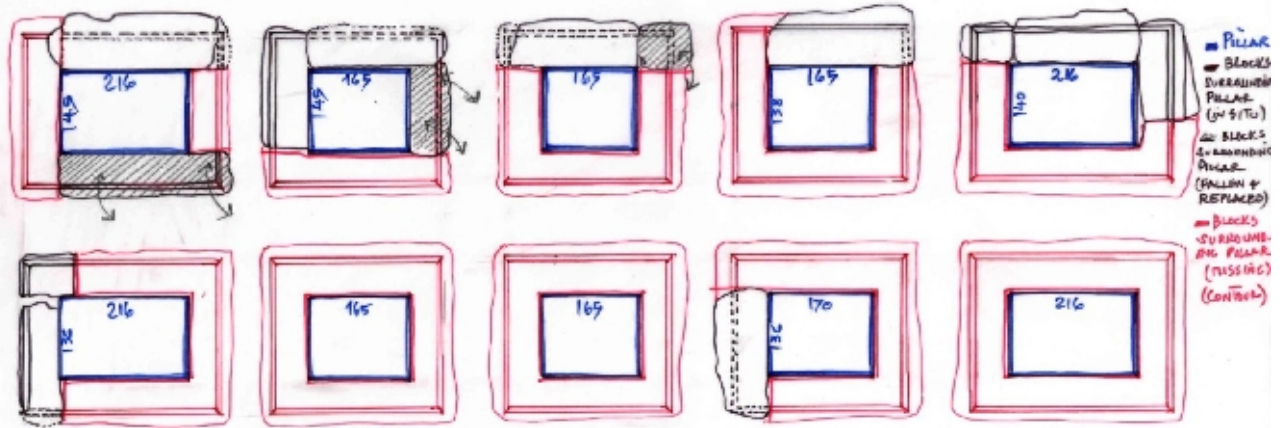
Fig. 7

A reconstruction where all missing blocks are drawn in red. The lower drawing presents the missing blocks without any separations, while the upper drawing is an attempt to divide the missing blocks of the northern row to manageable smaller blocks. For example: to complete the blocks around pillar No. 1, one needs to arrange three blocks as shown in the upper figure measuring 190 x 50, 215 x 50, and 80 x 50 each. The figure above gives just one possibility, many others can be produced. This gives the architect the advantage of having at least a possibility at hand for the matching from the scattered blocks in the area and so with some sense to categorize. Moreover, this kind of theoretical reconstruction sets the criteria for matching:

- Three dimensions are essential to satisfy the matching: the length, breadth and the height of the block.
- Type of the cut and the arrangements in situ might also serve as a clue. For examples in some cases blocks which are short on height are raised over debris to compensate for the shorter height.
- The angle of inclination of the sloped section of the blocks is also a last check before the execution of the works.

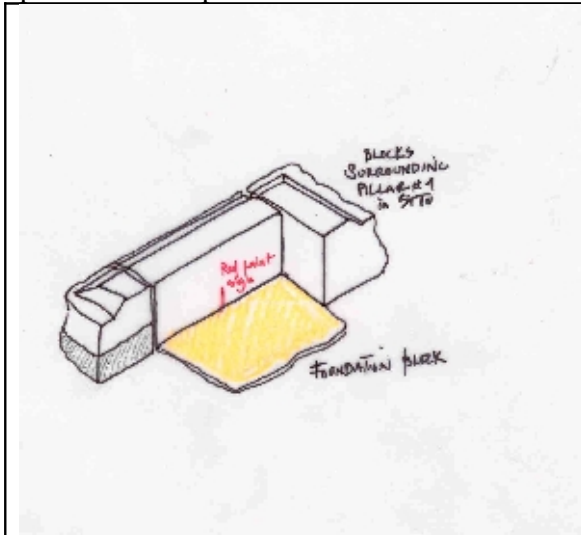
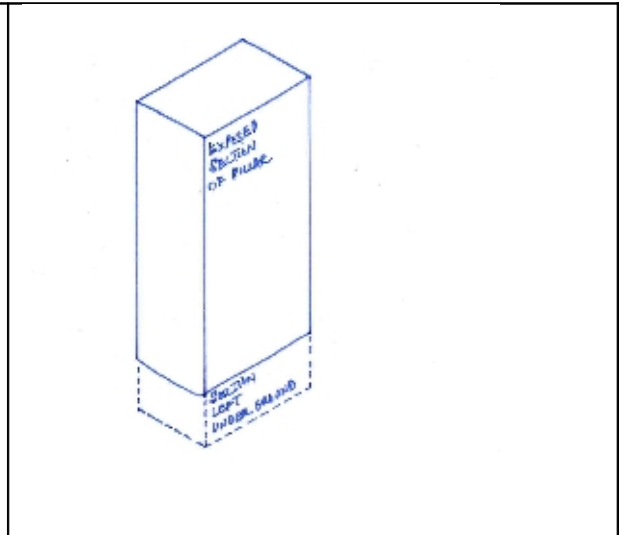
Fig. 9a

Finally, the architect Nairy Hampikian prepared a scheme of reconstruction for each of the pillars. Below, we have produced in the report the reconstruction of one pillar (number 1). The pillar is composed of a wide base, which is set and used as a planning platform to incise or paint or both on it the axes of the pillar. Once placing the pillar, at least six blocks are arranged around its four sides to add to the width of its base and by pushing with the blocks policed similarly around the pillar located on all sides of each pillar, a kind of continuous foundation is reproduced; perhaps the oldest

of its kind. These surrounding blocks have a slope on the opposite side from the pillar they hold. Structurally, the slopes in this direction give the impression of being bearing walls around the pillar. The upper left figure depicts all that has reached us in situ of pillar No.1. The blue drawing is a theoretical reconstruction of the pillar, where one meter of its shaft, if monolithic, is buried under the ground and reinforced from all sides by the framing blocks. If these are 5m above the ground, it means that nearly 29 percent of the exposed height is buried under the ground, which is again a fair portion of the pillar..

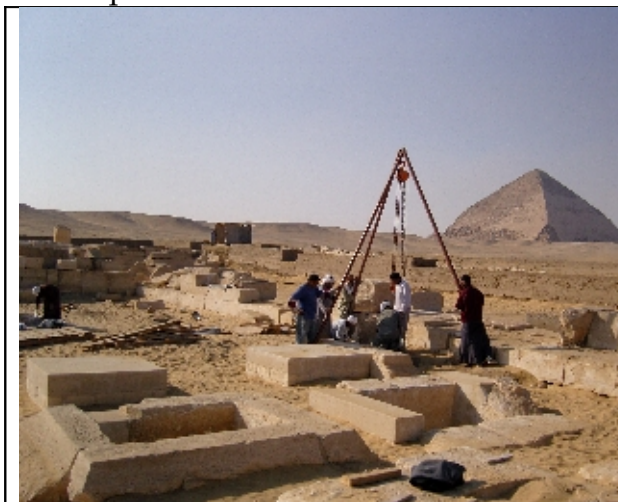
Fig. 10 Rebuilding the frame of a pillar with modern blocks

After having determined the kind of the construction of the pillars we decided to rebuild the first layers of the pillars with modern limestone blocks in order to give an impression of the porch.

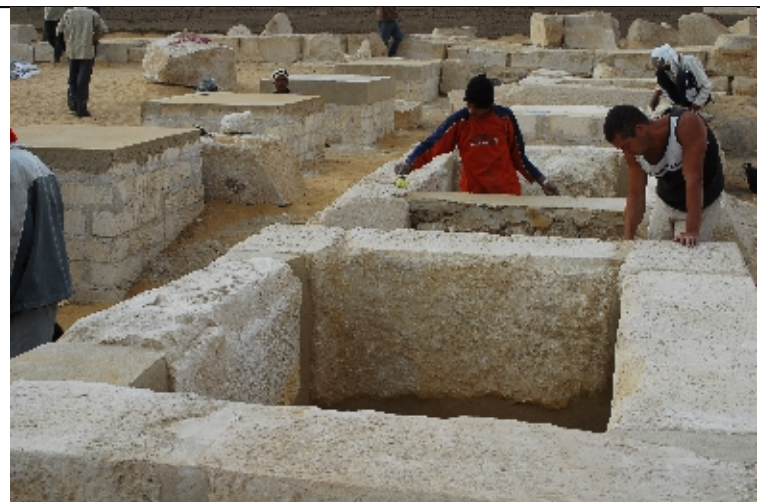
Fig. 11 The existing framing blocks of the pillars were put around the pillar foundations

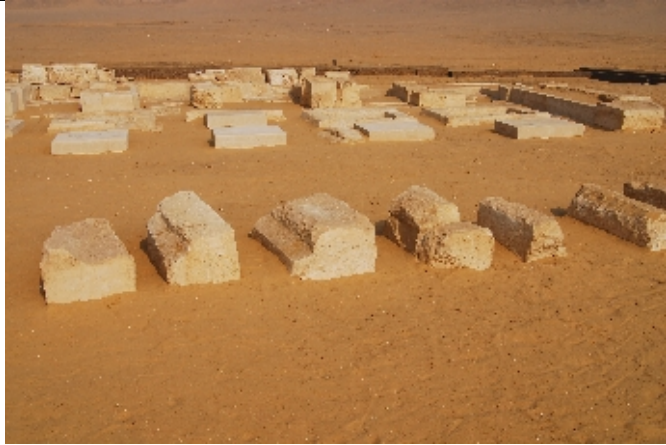
**Fig. 12** The open court refilled with sand and the pillars of the porch

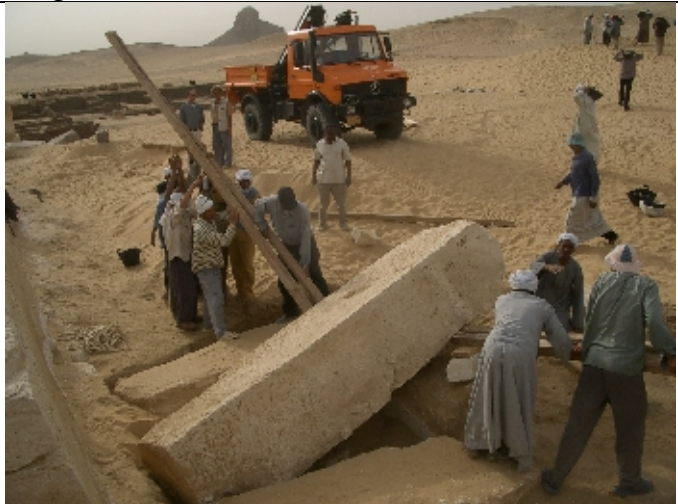
**Fig. 13** Re-erecting the western stela. On both side of the stela one recognizes the heavy frame stones. Inscriptions on these frames indicate that the stela was erected late in the year 29/30 of Senefru

The western stela was found lying in a deep sand bed. Fakhry had still discovered the top of the stela crowned with the name of Senefru. This part may be found in the so-called Fakhry magazine, a sealed mastaba tomb at Giza. We are hoping to be allowed to see this magazine in the near future and search for the relief.

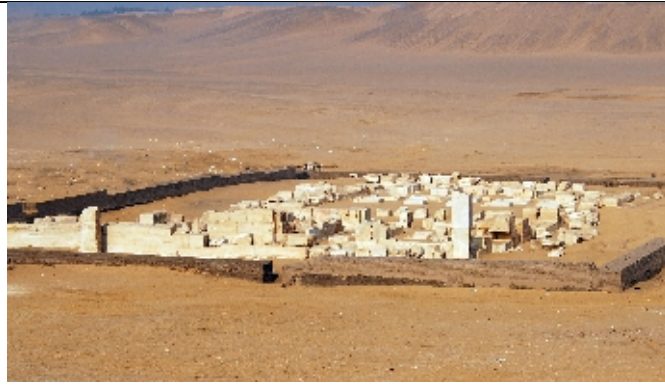
**Fig. 14** The south façade of the valley temple with the two stelae re-erected

Beside the eastern stela we discovered in the debris parts of the top of the stela. We reconstructed the stela according to the stela of Senefru in the garden of the Egyptian Museum.

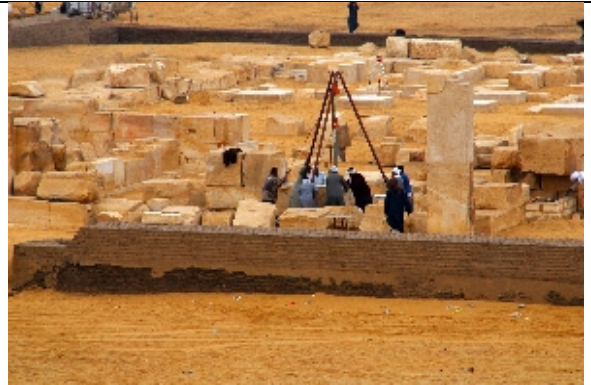
**Fig. 15** restoring the temenos wall of the temple

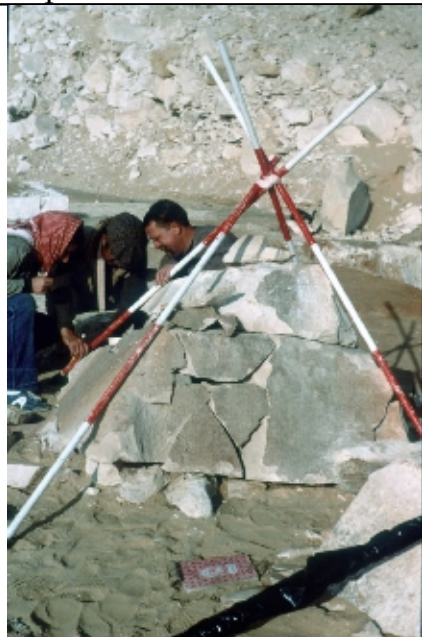
**Fig. 16 a** measuring the fragments of the pyramidion

The pyramidion of the Northern Pyramid of Sneferu had been found during the excavations campaign 1985. The measurements were taken by J. Dorner and later on it was restored by the restorer family Abd el-Qrety of Sakkara. During long years the pyramidion was misused by soldiers of the near army camp and visitors as a place to be used for inscribing their names on it. In autumn 2005 the pyramidion was dismantled again, cleaned and reconstructed according to the measurements on a high socle in order to prevent visitors to misuse it again.

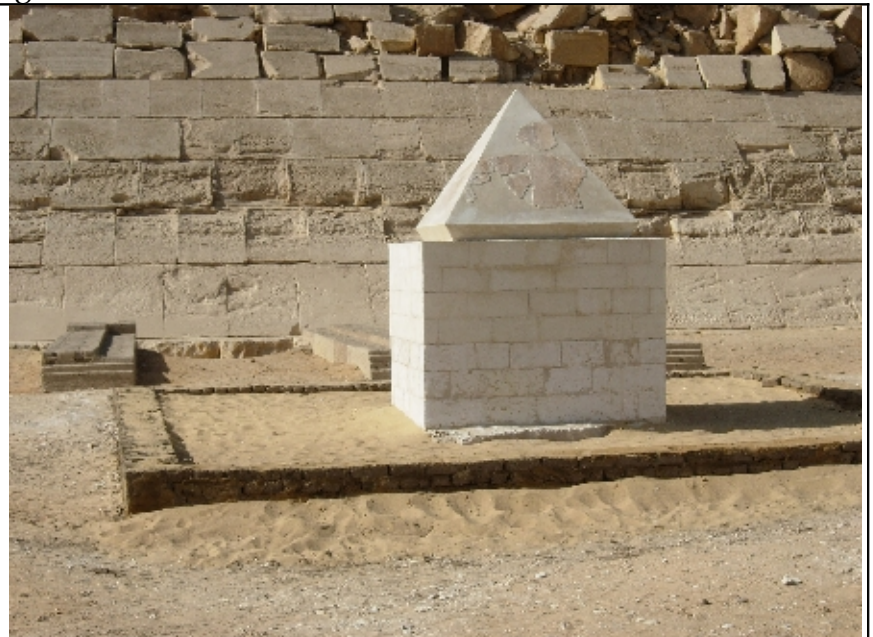
**b** The restored pyramidion of the Northern Pyramid

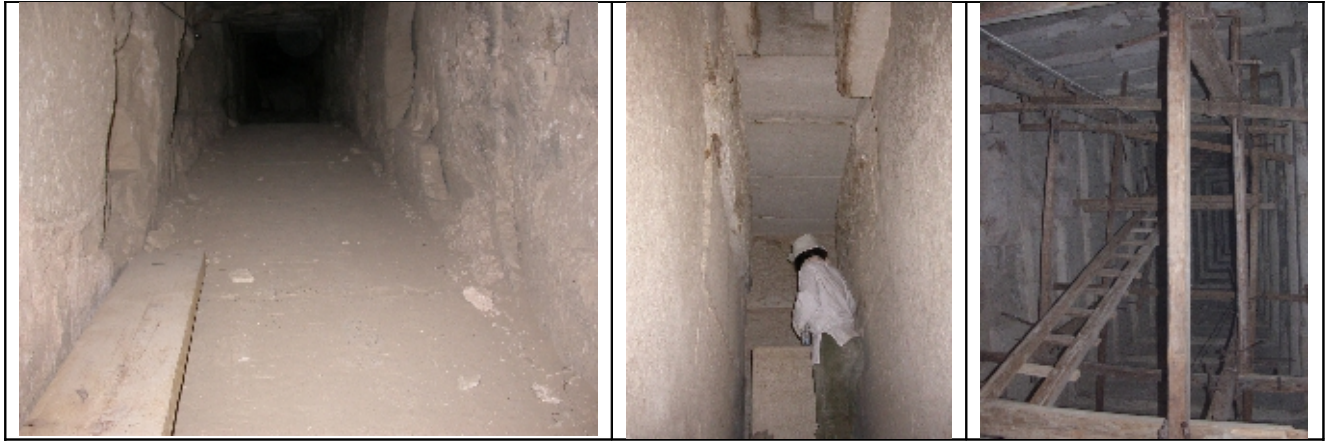
**Fig. 17** Measuring inside the pyramid: a the corridor, b the porticuli, and c the modern ladder leading up to the upper chamber

During the campaign 2005 the cleaning of the corridors of the pyramid was nearly completed. A new survey of all corridors and chambers was undertaken by Dr. Josef Dorner and Christian Perzlmeier. Some few measurements have to be added in spring 2008
